Case Studies in Construction Materials

Case study

In situ assessment of superficial moisture condition in façades of historic building using non-destructive techniques

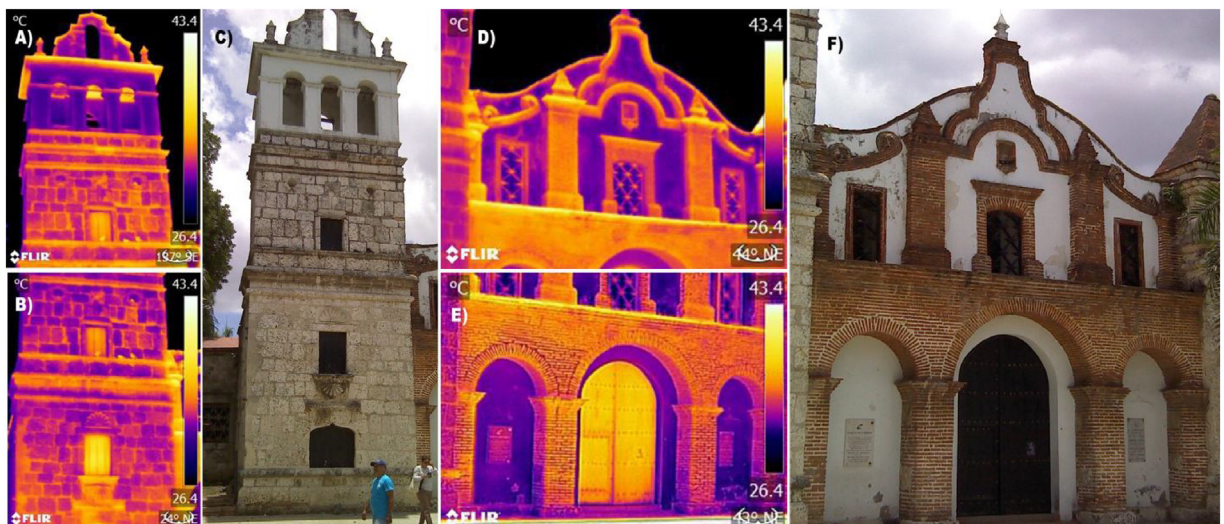
Fig. 6. A,B) Thermograms bell tower; C) Visual image of bell tower; D, E) Thermograms of main façade; F) Visual image of main façade.

In the Main Façade (south) the thermal images (Fig. 6E) shows that in the middle of the columns there are an area wet while the base was dry. This humidity is originated when rainwater and runoff water penetrate. Also in the upper part (Fig. 6D) there are moisture in a large area due to a) when rainwater and runoff water penetrate; b) humidity penetrates through cracks and through the loss of the lining or paneling c) rammed earth wall hygroscopicity, even though we can observe this humidity in the visual image (Fig. 6F).

While in the Bell Tower the thermal images indicate: a) Moisture originating from the subsoil due to the capillary action at the base of the bell tower when rainwater and runoff water penetrate; b) humidity penetrates through cracks and through the loss of the lining or paneling in some areas of the bell tower; c) rammed earth wall hygroscopicity. (Fig. 6A, B).

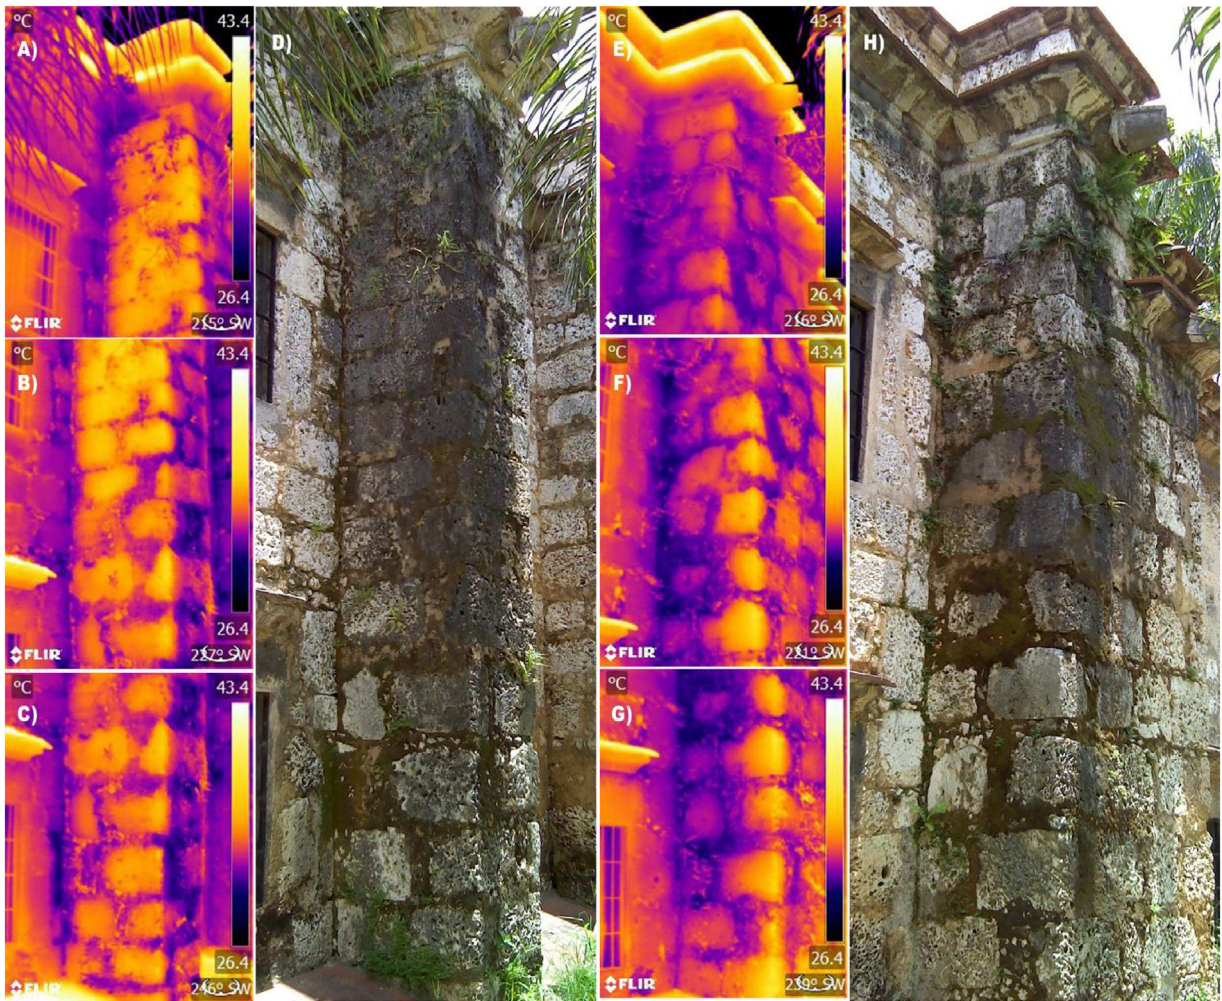
Fig. 7. A,B,C) Thermograms First buttress; D) Visual image first buttress; E,F,G) Thermograms Third buttress; H) Visual image of third buttress in north façade.

The North Façade present dampness in both walls and buttresses, caused by: a) ascending capillarity when penetrating rainwater runoff from facades; b) Moisture by filtration when the water penetrates the stone due to poor drainage in roofs, allowing the growth of vegetation and the formation of the black crust. (Fig. 7).

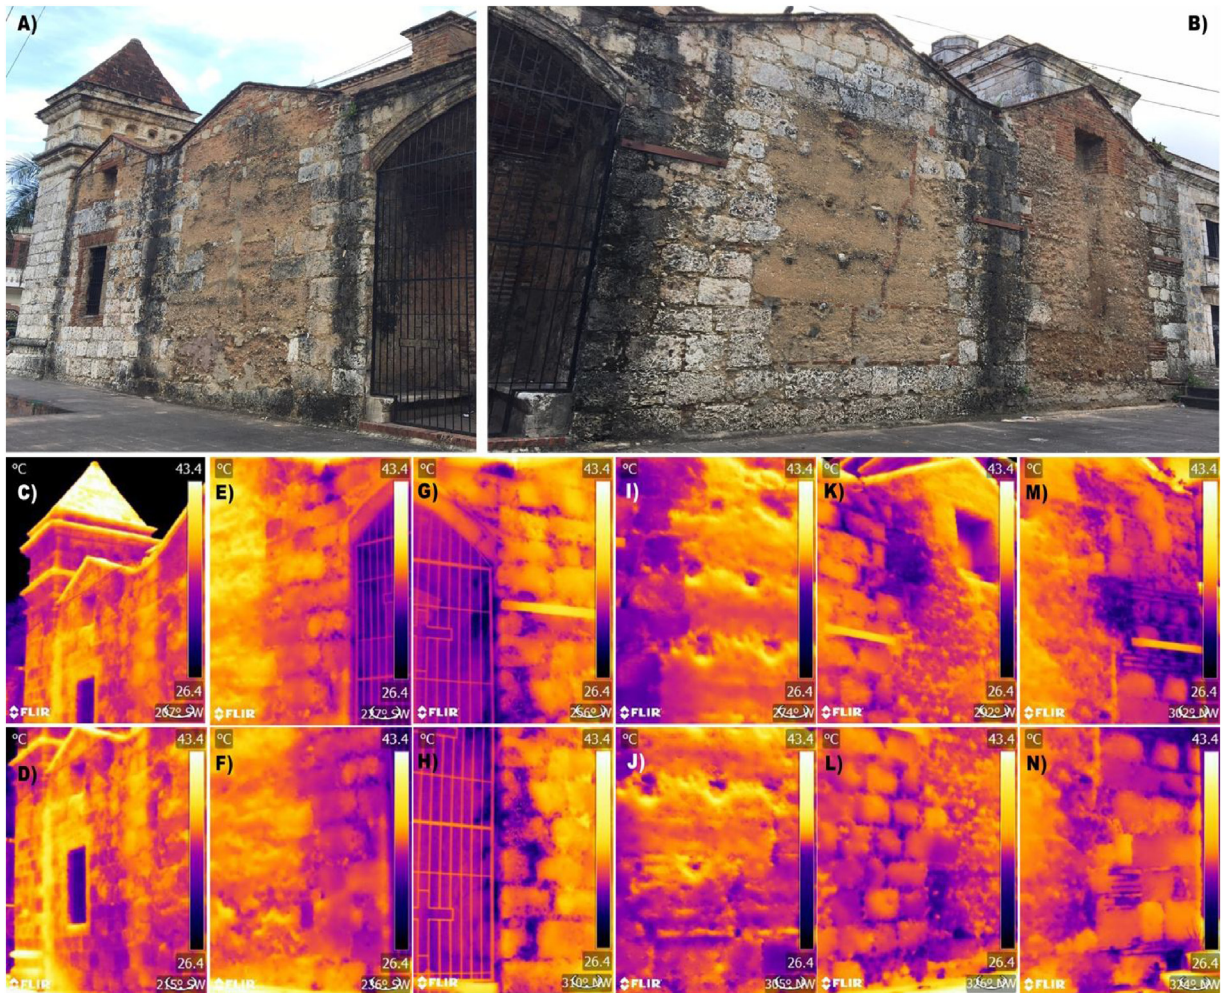
Fig. 8. A,B) Visual images of east façade; C-N) Thermograms of east façade.

In East façade observed a dampness in the walls caused by: a) ascending capillarity when penetrate rainwater runoff from facades; b) Moisture by filtration when penetrating the water through wall due to damage drainage in roofs and by the loss of plaster, allowing the growth of vegetation in some zones and formation of the black crust; c) rammed earth wall hygroscopicity. (Fig. 8). Most of the humidities are identify in the areas where the drainages are located, deteriorating the rammed earth and the coralina limestone.

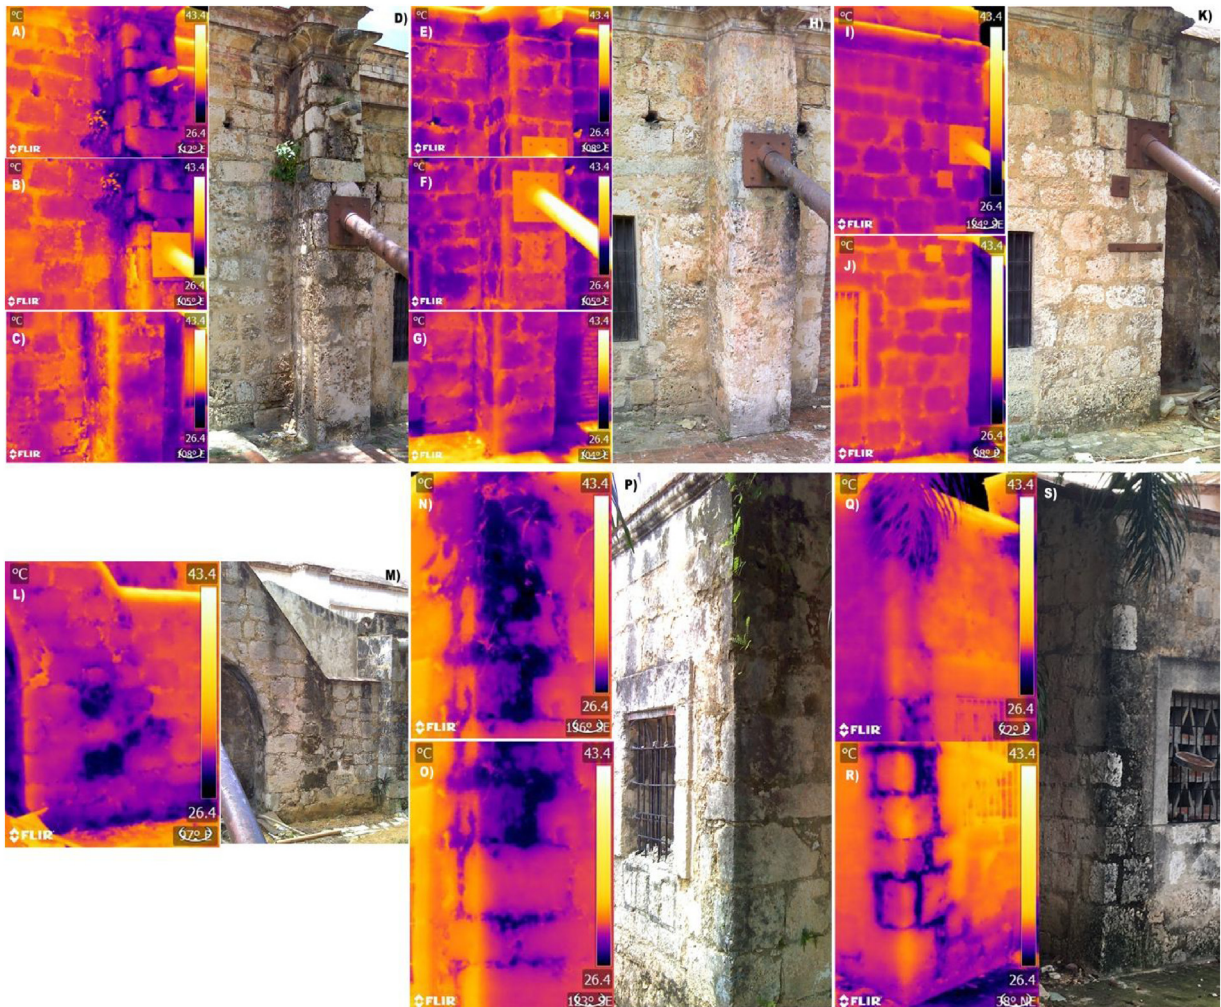
Fig. 9. A,B,C) Thermograms First buttress; D) Visual image first buttress; E,F,G) Thermograms Second buttress; H) Visual image second buttress; I,J) Thermograms Corner in west façade; K) Visual image of corner; L) Thermograms Stairs; M) Visual image of stairs; N, O) Thermograms Corner in west façade; P) Visual image of corner; Q, R) Thermograms Corner; S) Visual image of corner in west façade.

In West façade was observed dampness in both walls and buttresses, caused by: a) ascending capillarity when penetrate rainwater runoff from facades; b) Moisture by filtration when the water penetrates the stone due to damage drainage in roofs, allowing the growth of vegetation in some areas and the formation of the black crust. (Fig. 9). This humidities are deteriorating the façade with the consequence of major damages such as structural problems.

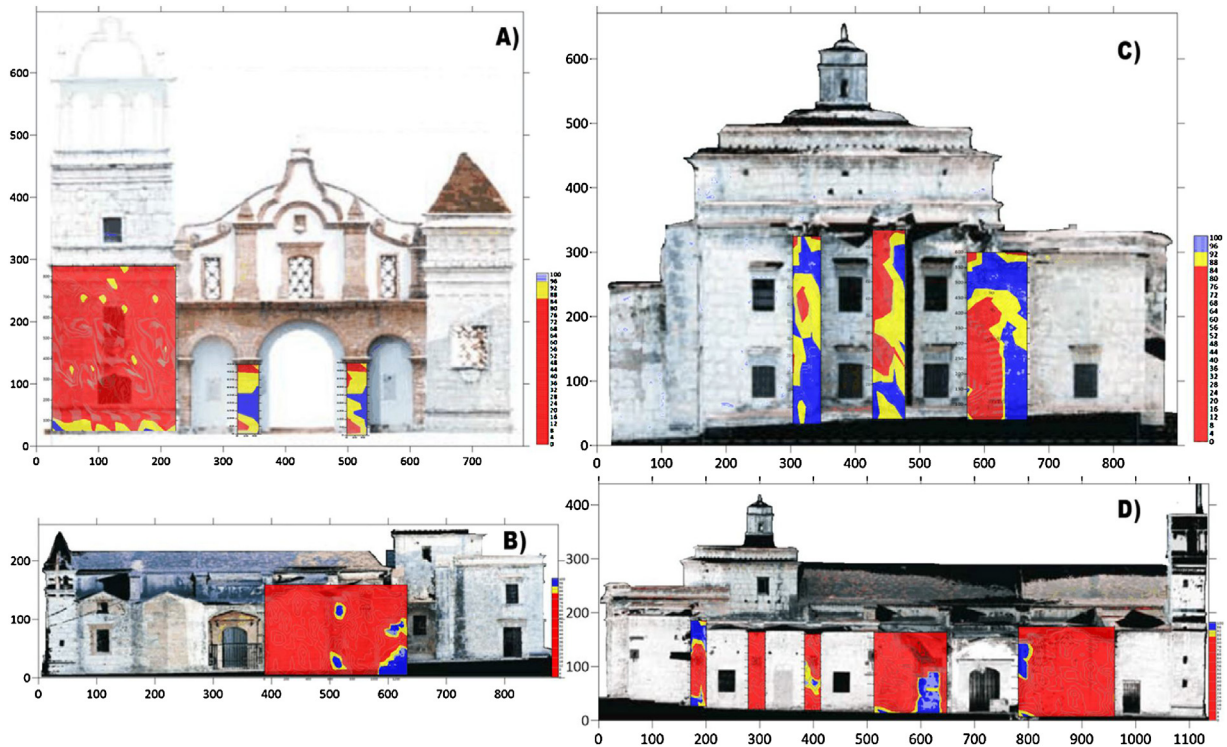
Fig. 10. A) Moisture in Main Façade (South); B) East Façade; C) Back Façade (North); D) West Façade.

The Moisture mapping shows the main façade (south), where the extent of wet and dry areas can be identified with different colors (blue color indicates a surface too wet (>95), whereas red color indicates a sufficiently dry moisture level (0–85) and yellow color indicates a borderline situation (85–95)). Fig. 10A) shows a great area sufficiently dry moisture in the bell tower with a few areas too wet in the base, whereas in the two columns there are an area too wet located in the middle and a few areas sufficiently dry moisture. Fig. 10B) shows a great area sufficiently dry moisture, also we can observe a blue zones located in the base and in some parts of the façade. Fig. 10C) shows a great surface too wet in the three buttress located

in different areas (base, top, middle), also there are areas with borderline situation (yellow) and sufficiently dry moisture (red). Fig. 10D) shows a great areas sufficiently dry moisture, also we can observed some areas too wet located in the base and the top of the façade.

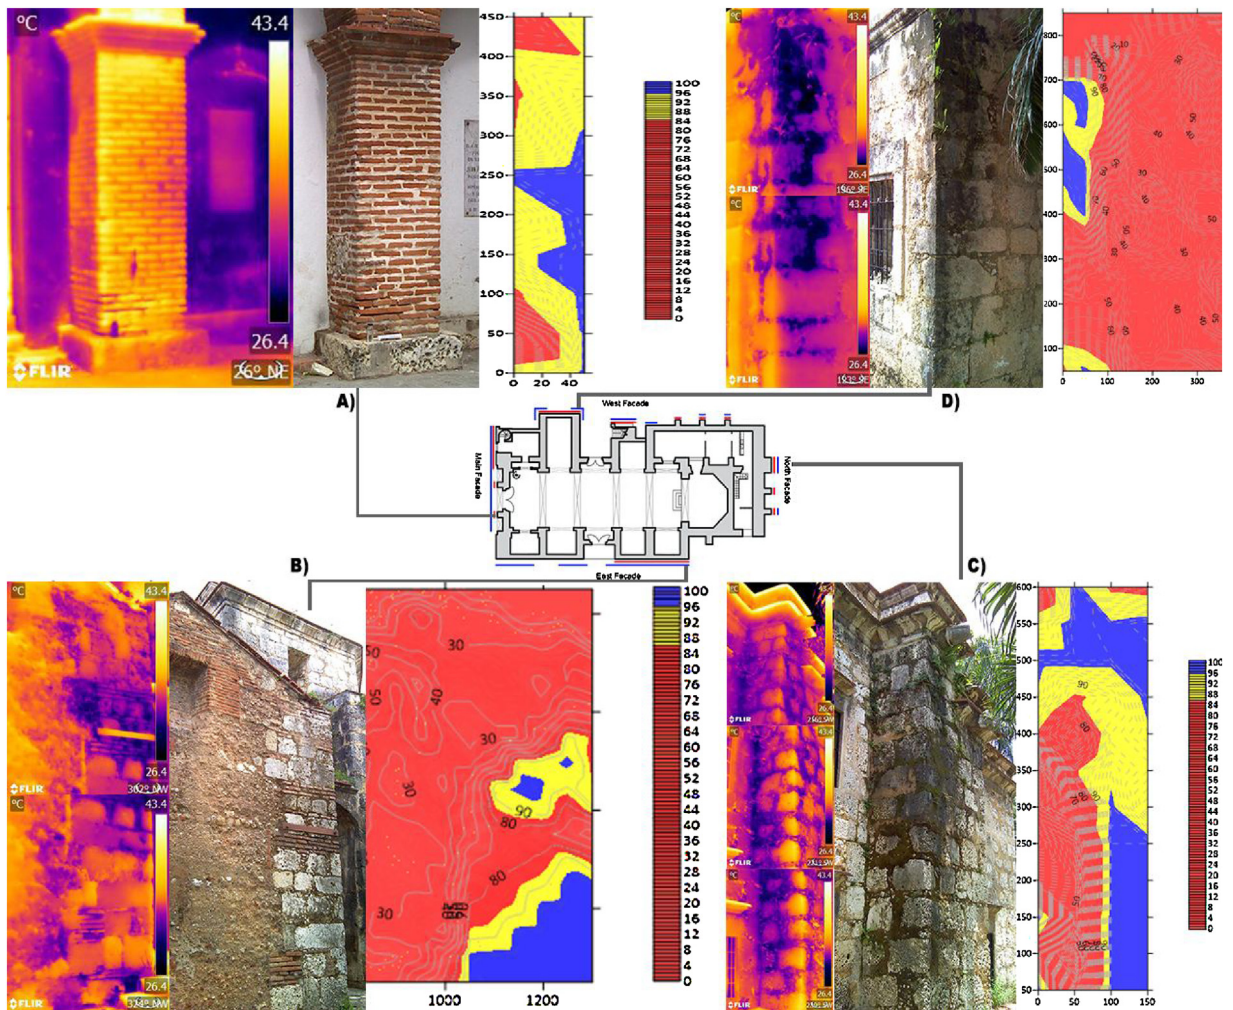
Fig. 11. A) Column in main façade (South); B) Corner in east façade; C) Buttress in back façade (North); D) Corner in west façade.

Fig. 11 shows a comparative between IRT and ERM of small part of each façades. Fig. 11A) shows a column located in the main façade where we can observe in both methods that there is a wet area in the middle of the column. Fig. 11B) shows a part of east façade where there are two areas too wet (>95) perfectly identify in the middle and in the base of the corner. Fig. 11C) shows a buttress in back façade where we can observe areas too wet in part of the base and top, also there are areas in the borderline situation (85–95) and others areas sufficiently dry moisture (0–85). Fig. 11D) shows a corner in west façade where we can observe in both methods that there is a wet area located in the top and in the middle of the corner.

Also in Fig. 11 we can observed that there is a difference in the results between both techniques, because of in ERM there is no difference between the joints and the stone or brick pieces, these occur due to the moisture was measured only in the stone and brick.
