Applications of Non-Destructive Techniques in the study of a Caribbean historic timber house

Virginia Flores Sasso^{1*}, Esteban Prieto Vicioso², Gabriela Fernandez Flores¹, Raquel Carreras Rivery³

2.1. Bodden Leroux house

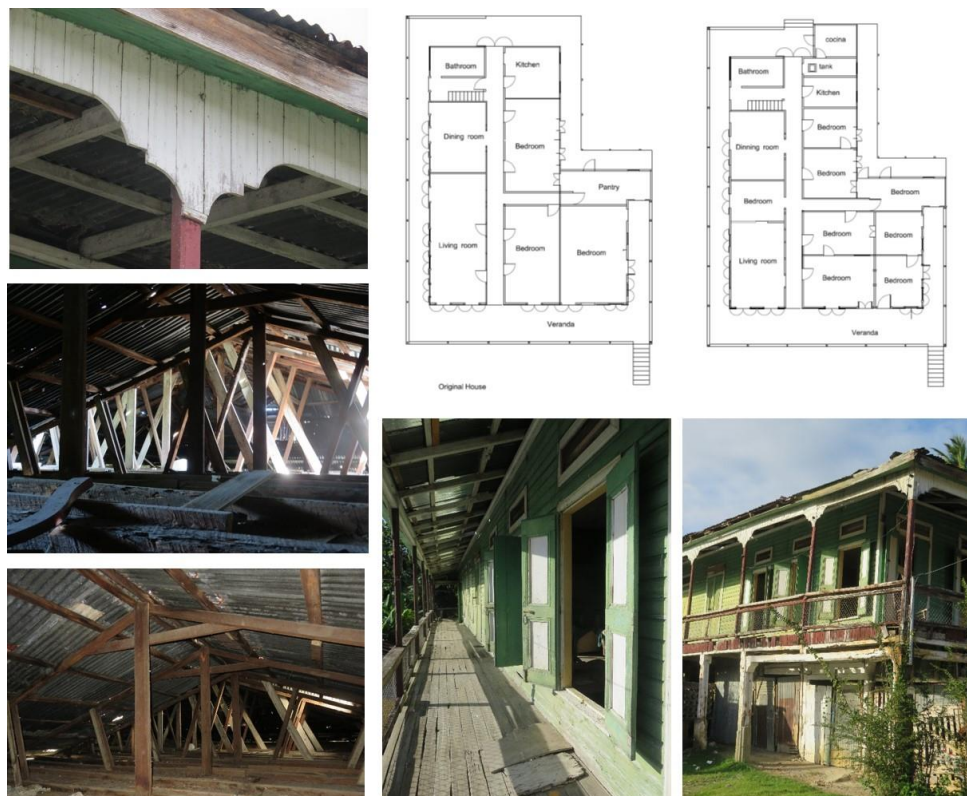
have a catalog house. The house is a simple layout with ornate wooden details, often called Farmhouse, National styles or American Foursquares. Was built on a sloping terrain, so it rose on wooden piles which makes it look bigger. It's a simple farmhouse with rectangular plan, divided into rooms that communicate by a central corridor and has a perimeter gallery where all the doors and windows open. The whole structure is made of wood, with horizontal siding plank pinewood boards of 13.97cm wide (5 1/2 inches). The floor of the house is also made of pinewood boards. The metal roof is hipped with four gabled dormer windows. The house has been modified and expanded. However its appearance has not changed much. Is currently abandoned (fig.2).

Figure.2. Details of Bodden Leroux's house (Prieto, 2018)

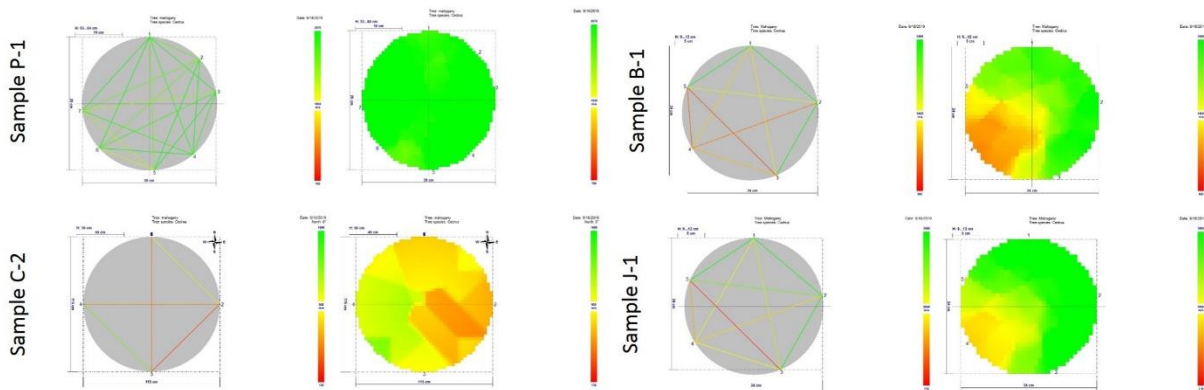
The ultrasonic testing enabled detection of deep and extremely small flaws within the material. In the Ultrasonic diagrams (Fig.2) can be observed that all the piles are in very good conditions (P-1), the column in the veranda (C-2) has some crack and deterioration due to humidity, a beam (B-1) in a roof has deteriorated and the joist present some deterioration. Even though some columns look dry when the tomography is carried out, it could be determined that they are in good condition inside. The same thing happened with the beams. The same thing happened with the elements that conform the frame of the building structure.

Fig.2. Ultrasonic diagrams of the samples P-1, C-2, B-1 and J-1.

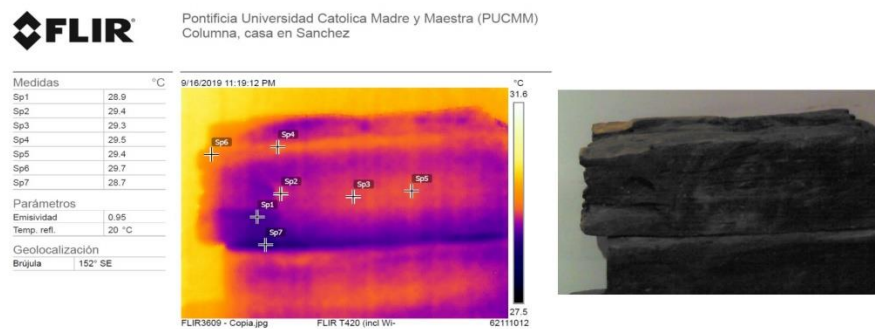
The thermography indicates that the thermal conductivity of wood is relatively low due to its porosity. As the humidity of the wood increases, so does its thermal conductivity. As the temperature of the wood drops, its strength increases (Fig.4).

Fig.4. Thermography of a piece of columns.

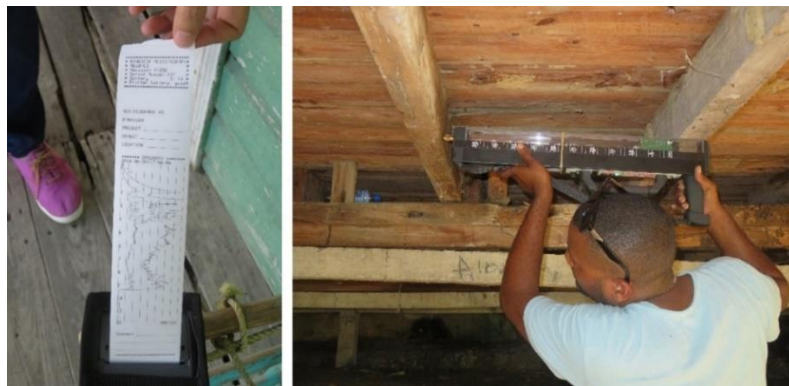
In some columns, the effect of the moisture content could be observed by finding little resistance with the drill of the resistograph. The permanence of moisture in the wood could be confirmed visually by the presence of fungi. This is important to know because it influences the mechanical properties of the wood.

Figure 6. Using the resistograph in a rafter under the floor (Flores, 2018)

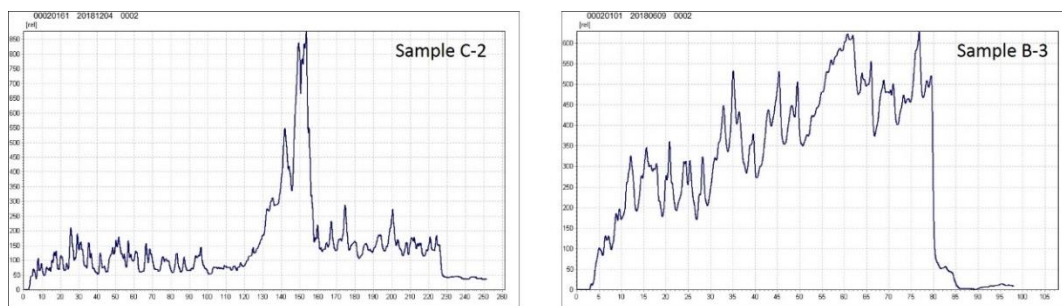
With the resistograph three drillings were performed in all these 12 pieces (Fig.6). The normal density values of *Pinus Strobus L* is 350-510 kg/m³, *Pinus taeda* is 450-550 kg/m³ and the *Copaifera officinalis L.* is 601-810 kg/m³. The averaged form the average Mean drill resistance [rel] of the samples indicated that the density of the pile are higher than the normal value, the C-1 and C-2 are within the normal range but C-3 is higher. The density of the samples of the beams and joist are higher (Table 2).

Figure 4. Resistance graphs. On y-axis measured quantity [rel] and on the x-axis the depth (mm).
