Case Studies in Construction Materials

Case study

In situ assessment of superficial moisture condition in façades of historic building using non-destructive techniques

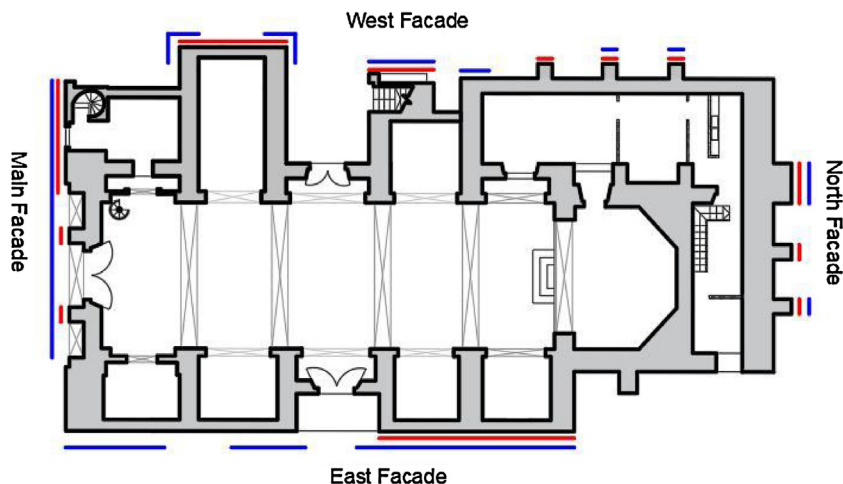
Fig. 4. Study areas with Portable Moisture Tester (Red Lines) and Thermal Camera (Blue Lines).

An area was selected on each facade to measure brick and stone (Fig. 4). For the data collection, a 50 x 50 cm mesh was used and it was measured in each of those points with the portable moisture testes along the façades from ground level to the roof. Before the survey the DELMHORST BD-2100 was calibrated. Once the values were obtained, they were introduced in the program Surfer V15 develops by Golden Software [44]. In this program an interpolation of the data is done to obtain the humidity maps of each façades. For moisture mapping we used the blue color to indicate that the surface is too wet (> 95) whereas red color indicates a sufficiently dry moisture level (0–85) and yellow color indicates a borderline situation (85–95) [42].
