Applications of Non-Destructive Techniques in the study of a Caribbean historic timber house

Virginia Flores Sasso^{1*}, Esteban Prieto Vicioso², Gabriela Fernandez Flores¹, Raquel Carreras Rivery³

2.1. Bodden Leroux house

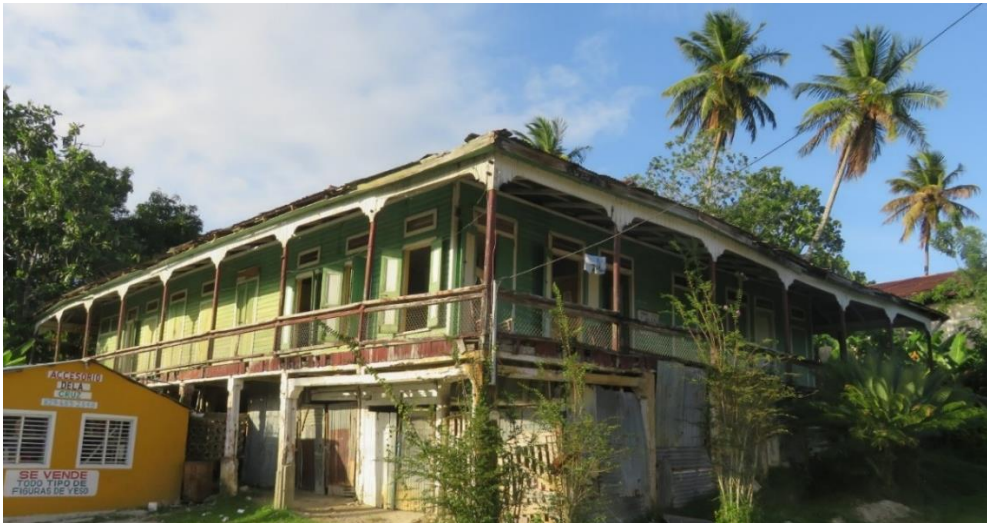
Figure.1. Bodden Leroux family house (Prieto, 2018)

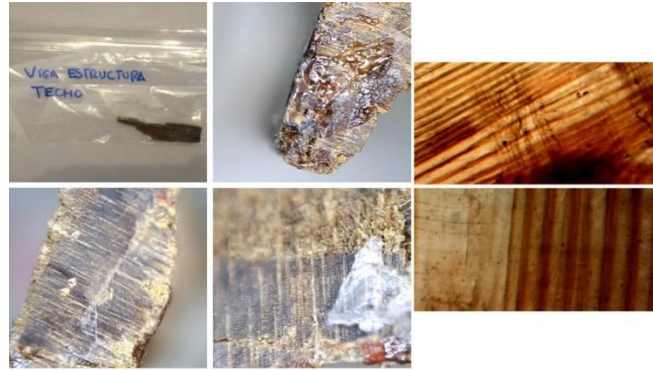
It was identified that all the piles are *Copaifera officinalis* L. (Amacey o Cabima), the beams, joist, decorative elements, some boards, the wood frame are *Pinus Strobus* L. (White Pine, Northern White Pine), the boards in the house extension and the repair woods are *Pinus taeda* (southern yellow pine). This indicates that the house was brought from the north of the United States, which was very common in the late 19th century (Fig.3). The piles are made of local wood. This was also very common, as the level of the house was resolved on site. The extension of the house and the repairs are

Fig.3. Wood of structure of the house (*Pinus Strobus L.*) (Carreras, 2019)
